# Public Informational Meeting

## Bridge Preservation NHDOT Project No. 41483

Gilford Bridge 102/099 – NH Route 11 over Gunstock River

Gilford Bridge 138/137 – NH Route 11A over Poor Farm Brook

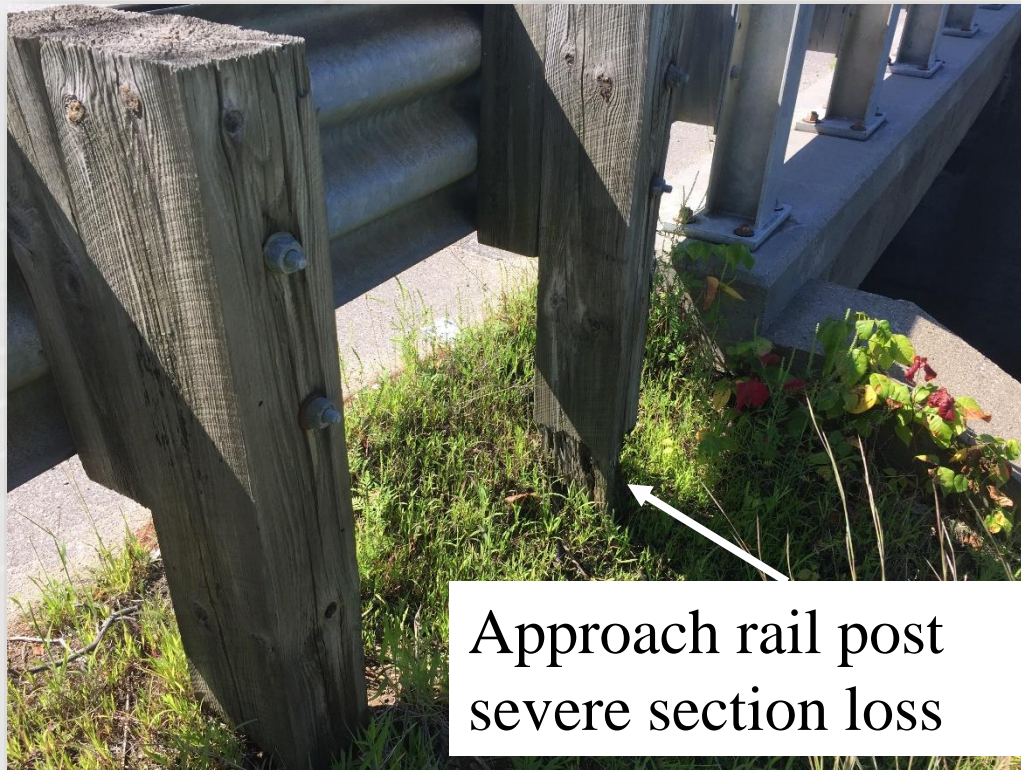
Approach rail post  
severe section loss

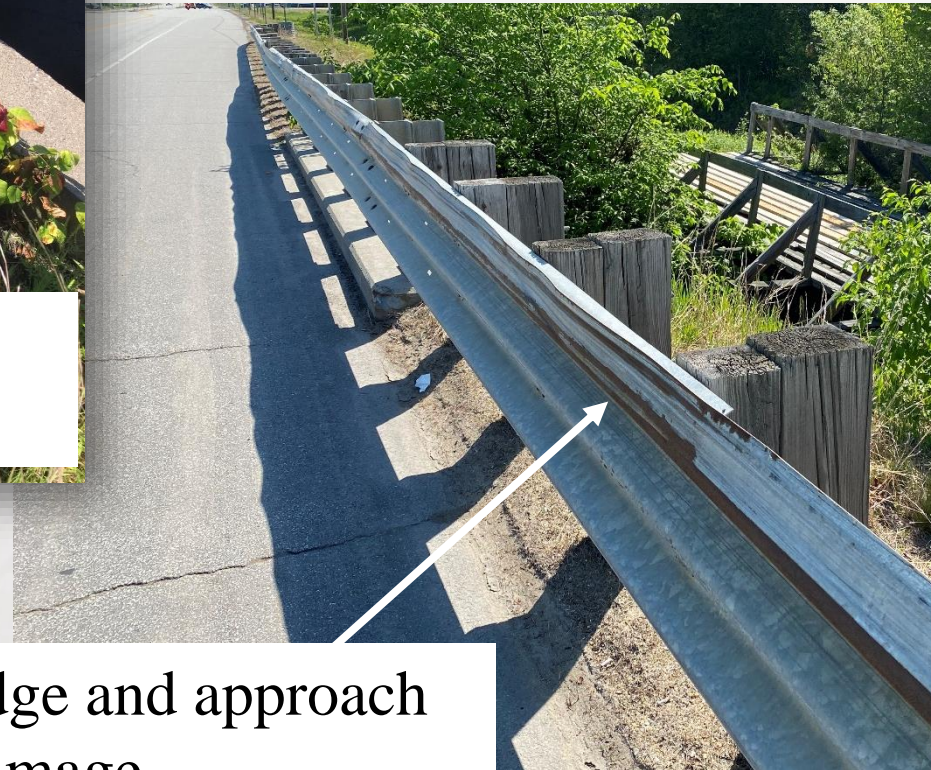
Typical bridge and approach  
rail plow damage

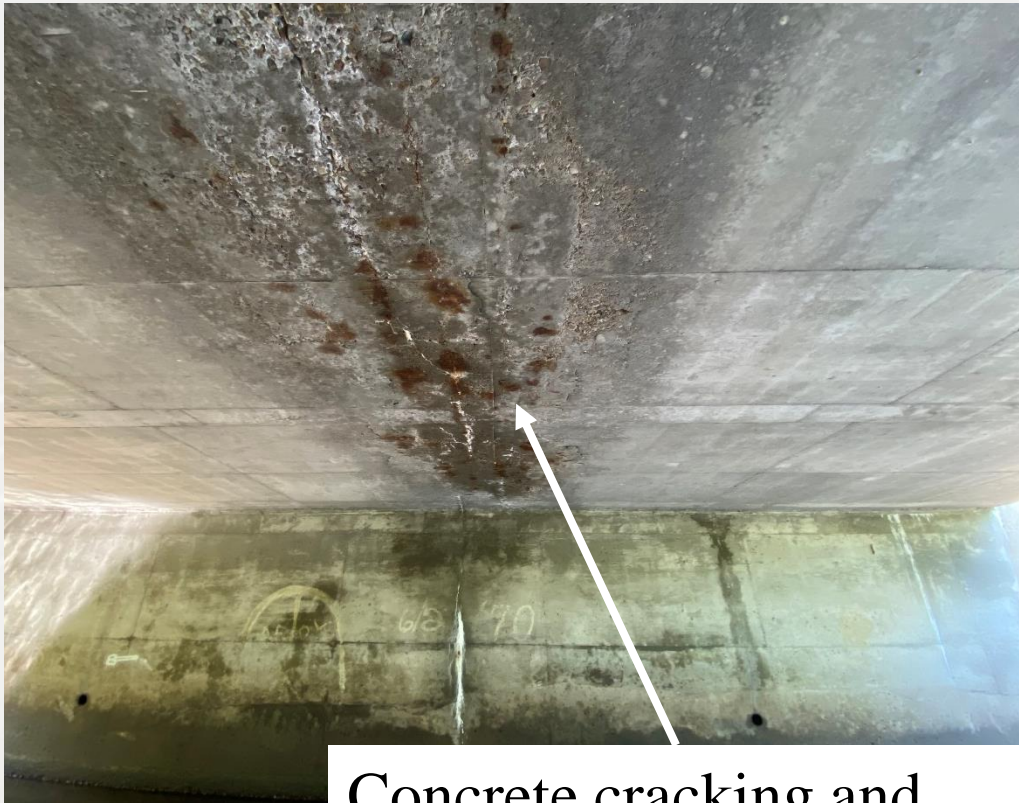
Concrete cracking and water infiltration at center of bridge deck

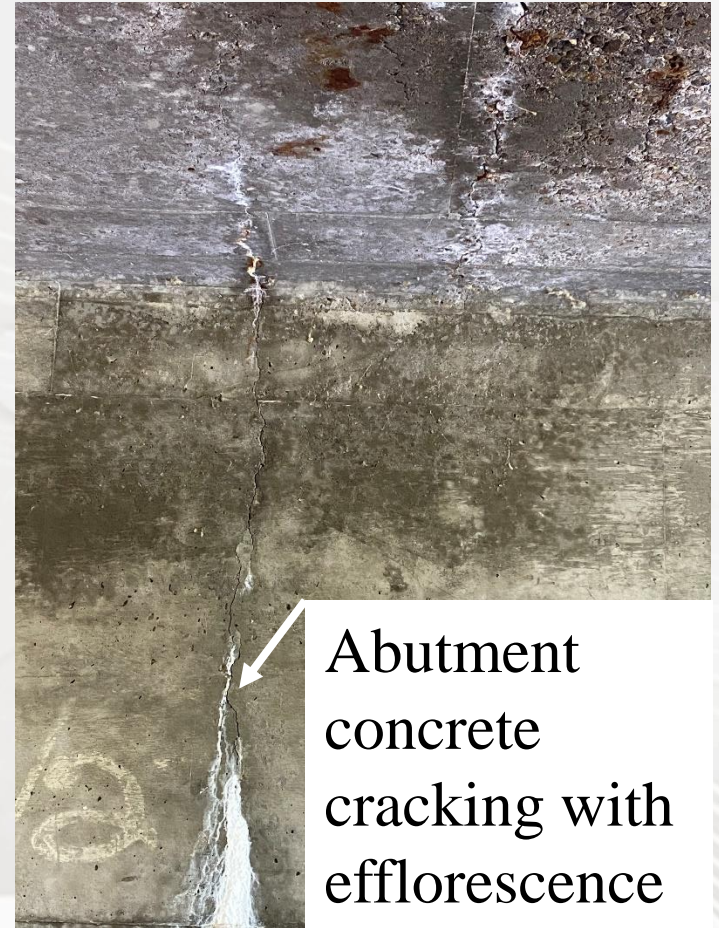
Abutment concrete cracking with efflorescence

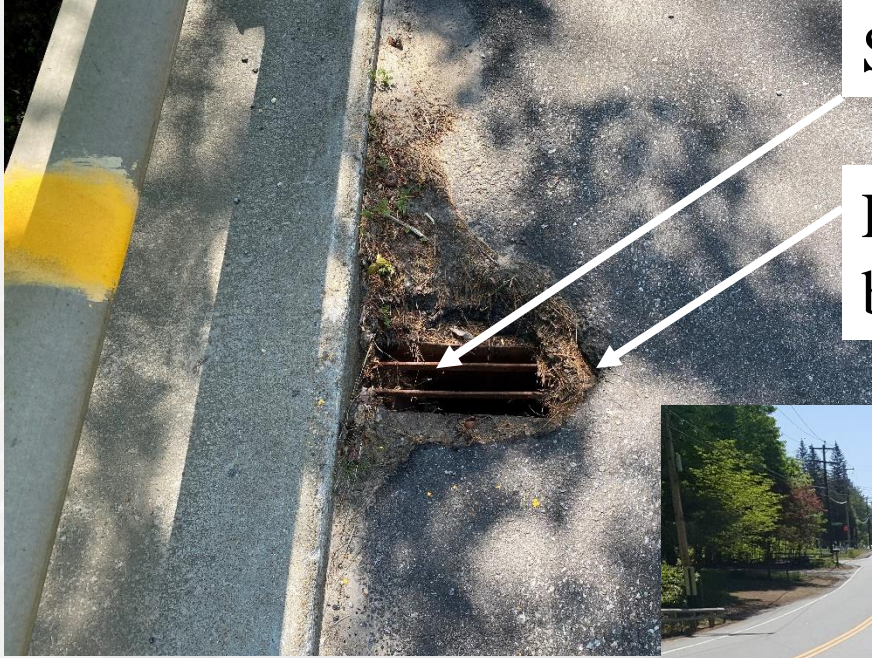
Scupper to be removed

Excessive pavement over bridge

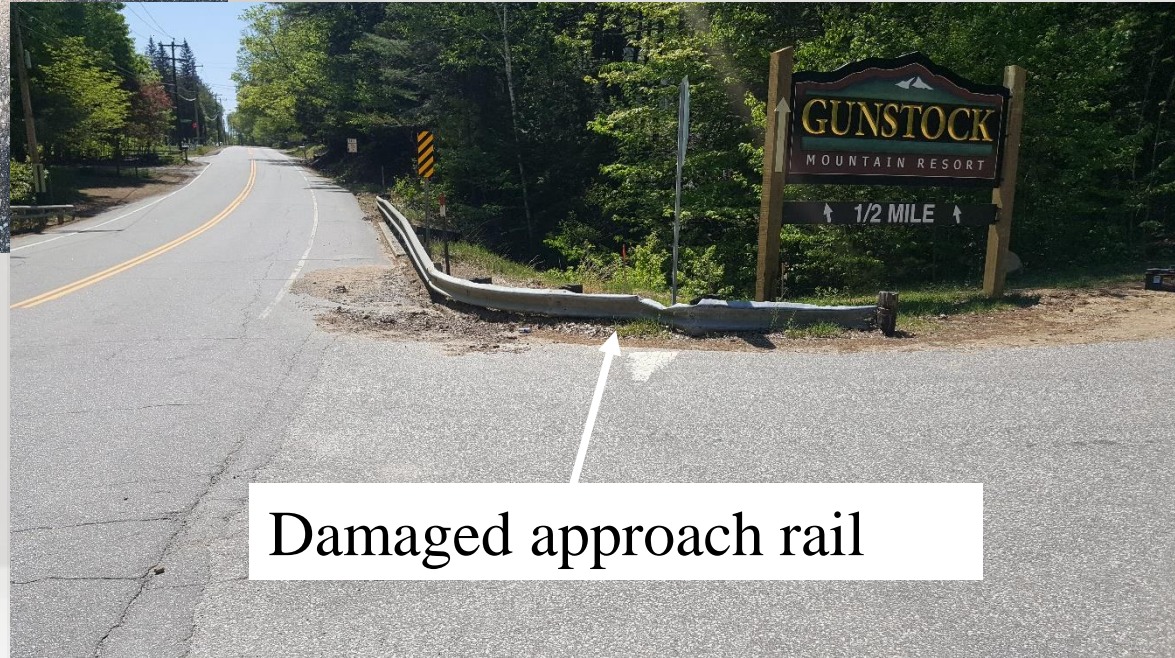
Damaged approach rail

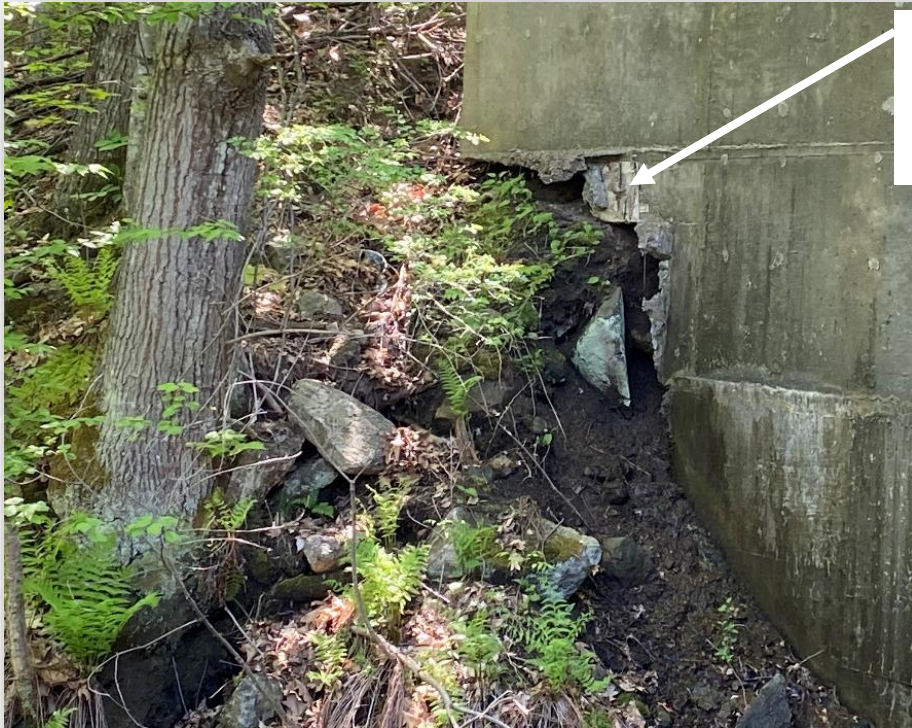
NE wingwall undermining  
from bank erosion

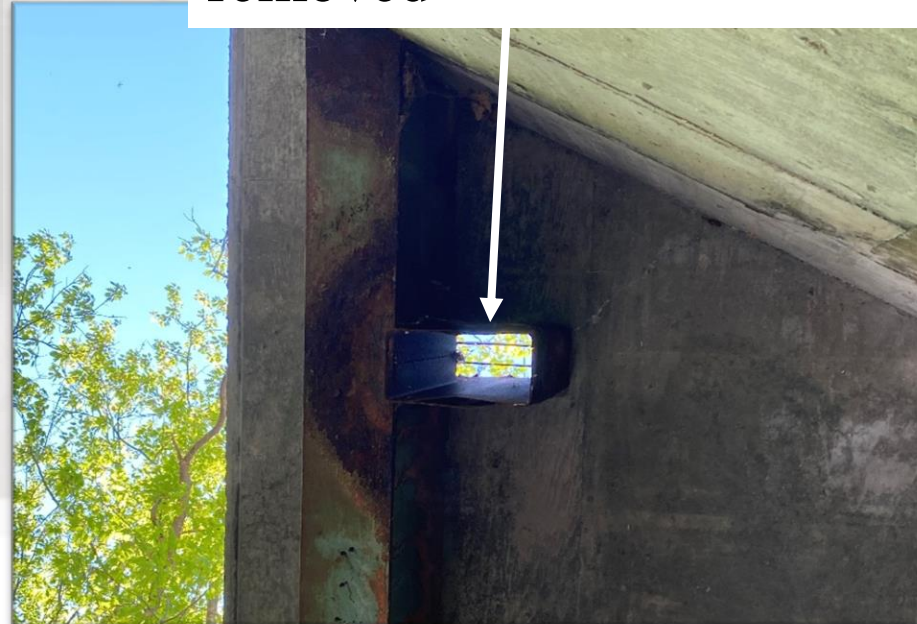
Deteriorated scupper to be  
removed

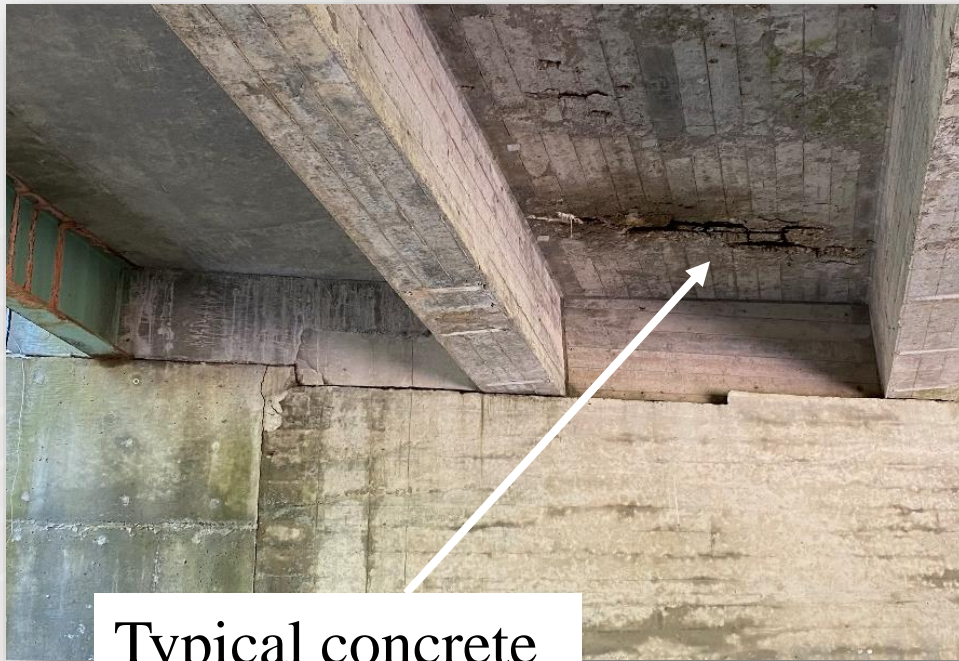
Typical concrete  
deck spall

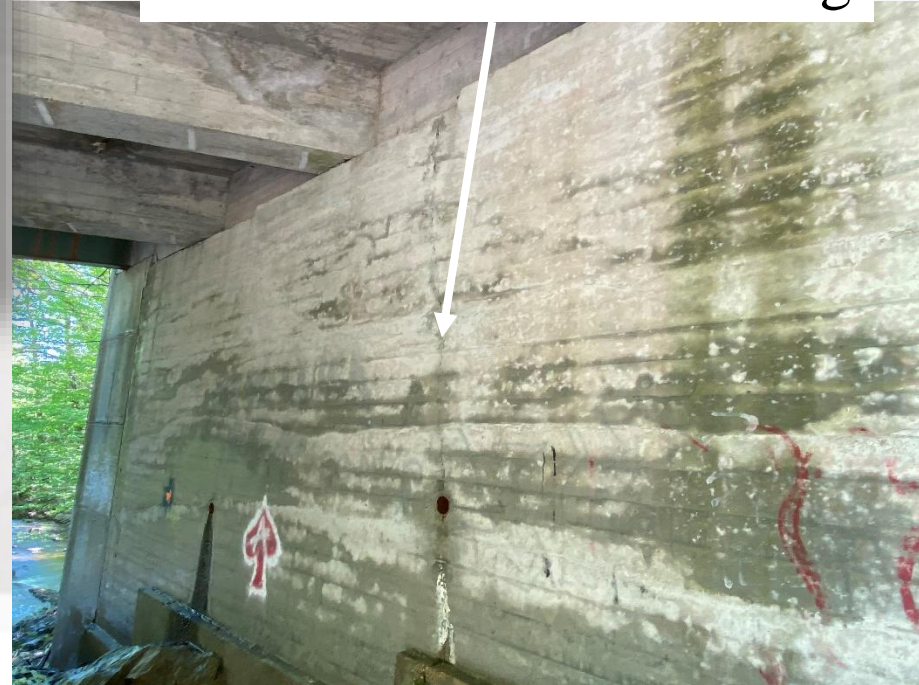
Abutment surface cracking
